Door frame, window frame and pipe detail

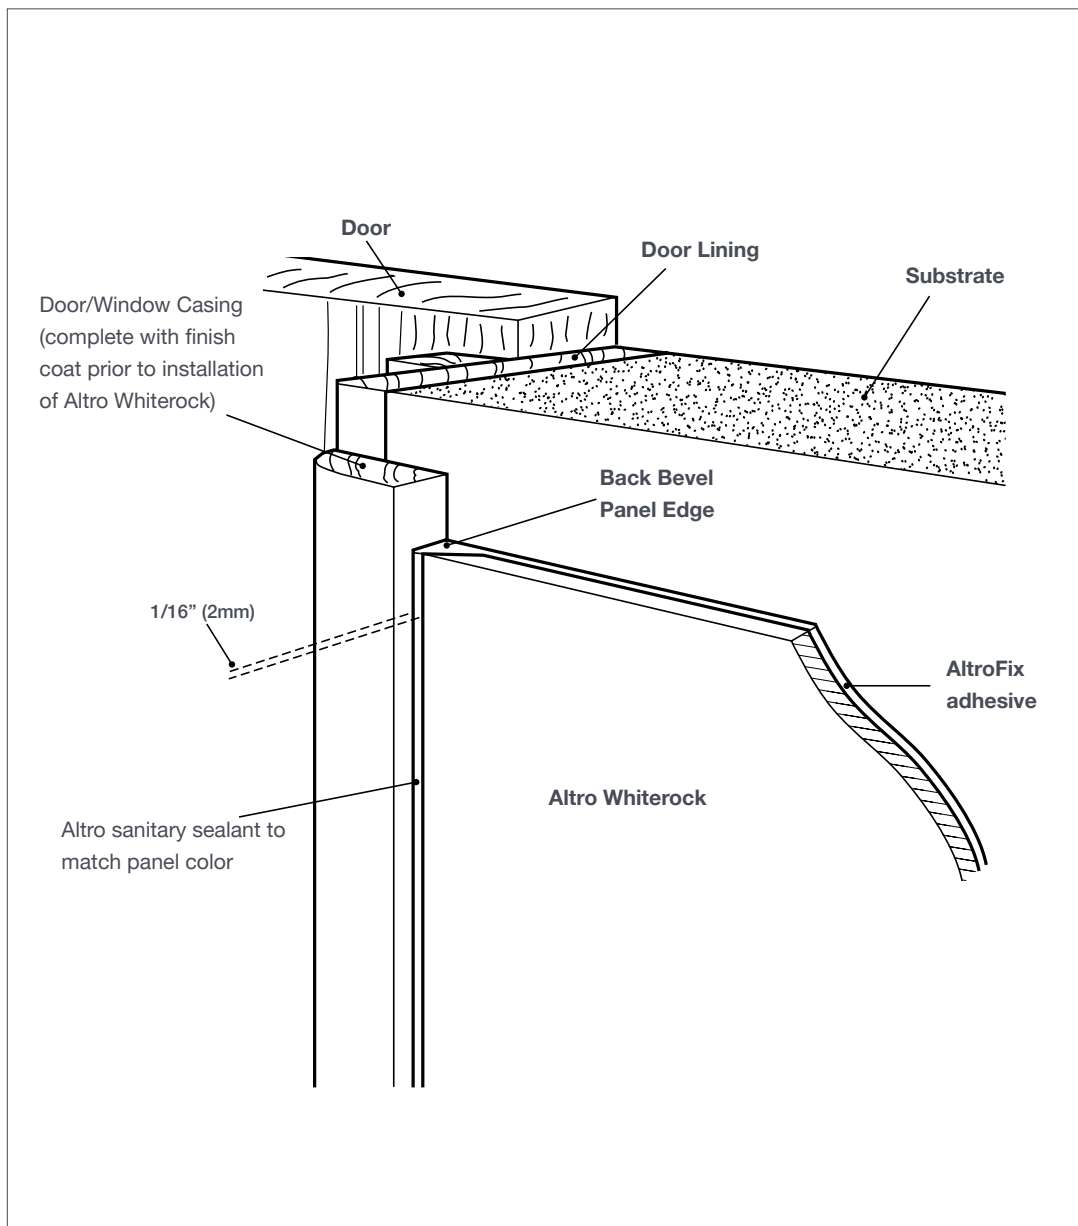
Altro Whiterock hygienic wall system sealed to door frame.
